Request for Bids (RFB)

318 Poplar Street
Columbia Borough
Parcel Number: 110-04563-0-0000

RFB – 318 Poplar Street, Columbia, PA

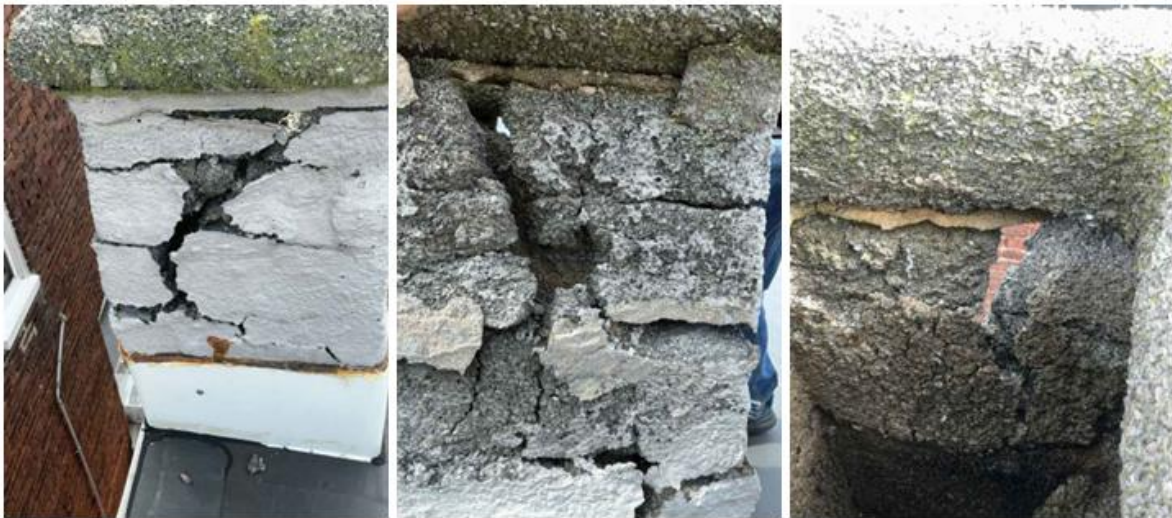
3.3.1 Skylights, Chimneys & Roof Penetrations

CHIMNEY BLOCK CRACKING AND OR MORTAR DETERIORATING

The chimney block above the roofline is significantly deteriorated. The chimney above the roofline appears to need a complete rebuild. block is cracking and mortar are significantly deteriorated. If not repaired, the continued deterioration will make the chimney unstable and could cause significant damage to the structure. The house is currently an all electric house so there is no need for a chimney. This chimney could be abandoned if the owner desired. I recommend evaluation, and repair by a chimney repair contractor.

Item	Cost
1. Replace furnace filter in basement heat pump.	
2. Repair deterioration on chimney block above building roofline. Repair cracking on brick and mortar to ensure stability of structure. See Attachment A for photos and description of damage to be repaired.

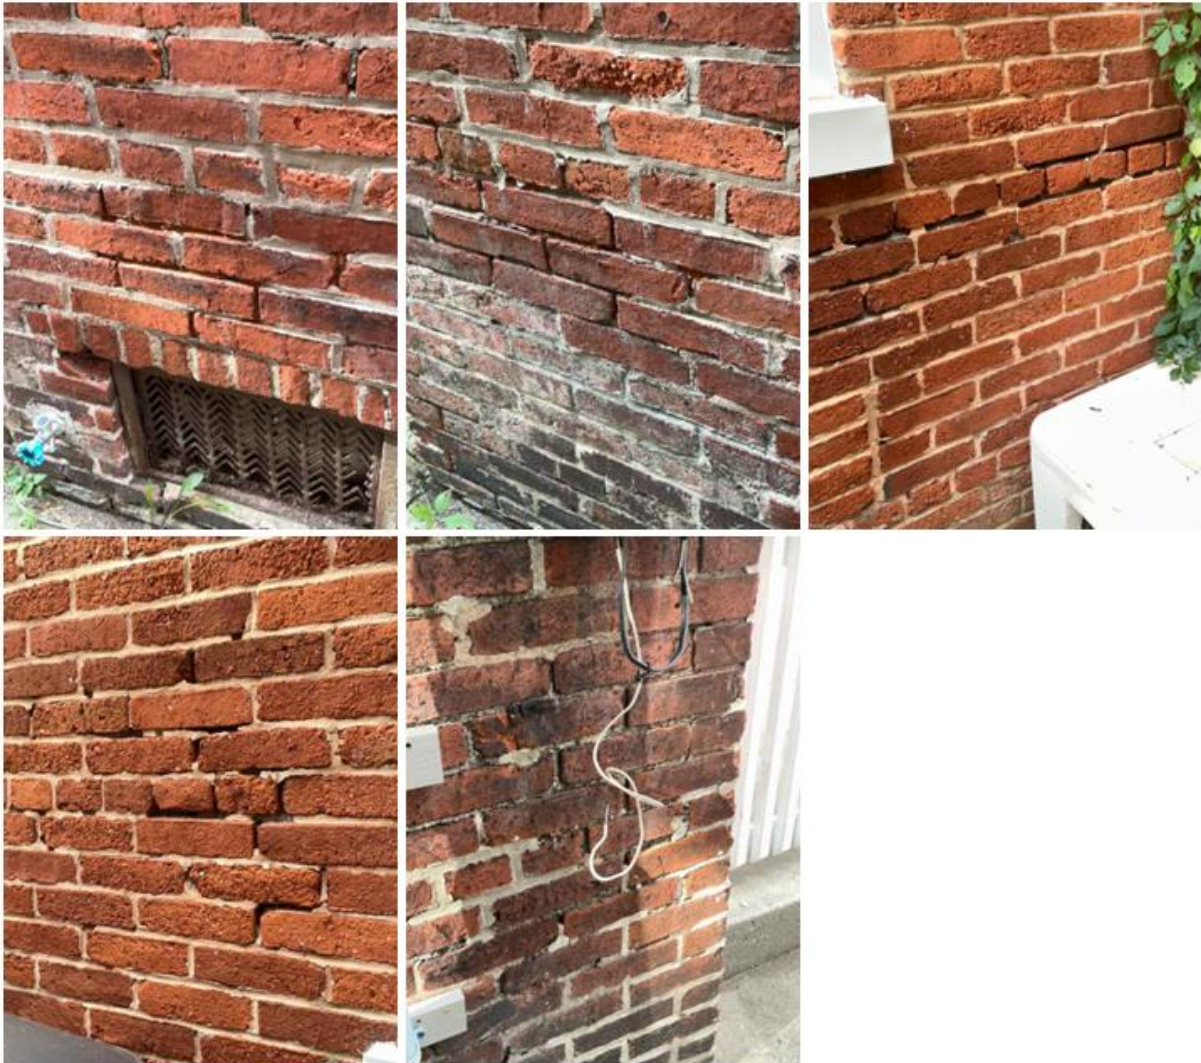
4.4.1 Siding

MORTAR ERODING OR MISSING -MODERATE

Mortar is eroding and/or missing. This condition allows for moisture to penetrate behind the masonry, potentially to cause the masonry to come loose. I recommend a qualified professional to evaluate. Consider mortar repointing.

3. Repair eroding or missing mortar on building's exterior. Ensure water tightness and repoint where necessary. See Attachment B for photos of damage to be repaired.

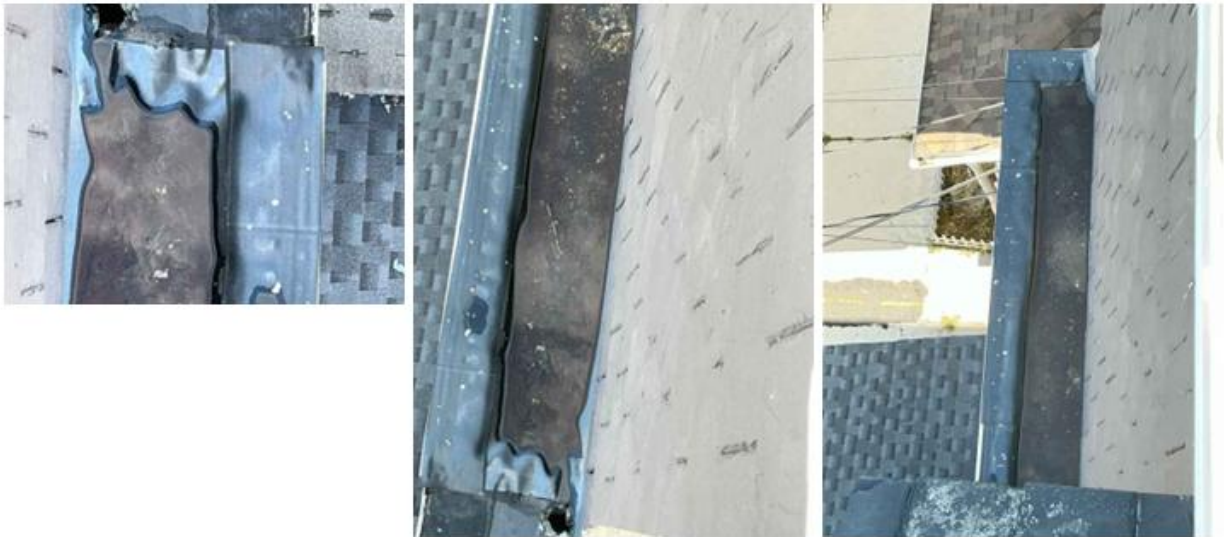
3.1.1 Coverings

PORCH ROOF WITH BUILT IN GUTTER DOES NOT DRAIN

The built-in gutter at the front of the house does not drain properly. There is standing water in the body of the gutter Or roof. When properly installed, the gutter is sloped toward a recessed area whose bottom has a drain hole that channels the rainwater into the downspout. There is an obstruction that is trapping the rain water in the gutter and preventing it from draining. A roofing installation and repair contractor should be called to repair this condition and restore the built-in gutter to full function.

4. Repair built-in gutter on porch roof to ensure proper drainage, making sure opening properly allows standing water to channel downward to drain. See Attachment C for photos and description of damage to be repaired.

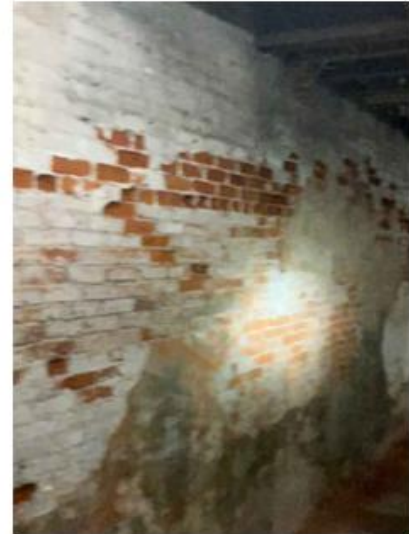
6.1.1 Foundation Structure

MASONRY AND MORTAR SOFT, CRUMBLING

At the time of the inspection the mortar in the foundation wall was soft and crumbling. This condition is common in older homes with stone, block or brick foundation walls and is most likely due to the quality of the mortar mix and/or moisture penetration. I recommend a qualified professional to evaluate and repair or repoint.

5. Repair or repoint soft, crumbling mortar on building's foundation (located in basement), ensuring water tightness. See Attachment D for photos and description of damage to be repaired.

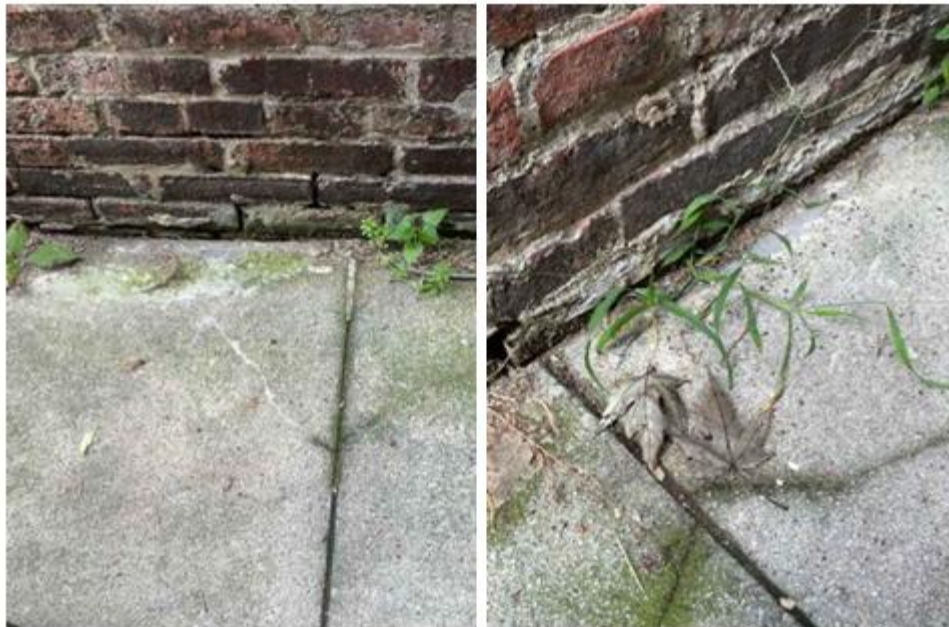
4.9.1 Foundation Wall Exterior

GAPS BETWEEN FOUNDATION WALL AND EXTERIOR WALL OR WALKWAY

At the time of inspection there were gaps (openings) between the foundation wall and the exterior wall or walkway. These openings are vulnerable to rainwater intrusion into interior, usually into basement. Hidden damage may exist. Repair with mortar for a permanent repair, by a professional handyman.

6. Repair gaps (openings) between the foundation wall and the exterior walk or walkway with mortar to ensure water tightness. See Attachment E for photos and description of damage to be repaired.
